Crash Reports

FIGHTER COMMAND ACCIDENT INVESTIGATION BRANCH

Date of Accident	Precise Number	Aircraft	Unit
22 January 1943	W1437	Spitfire IX BR 141	64 Squadron

FLYING ACCIDENT

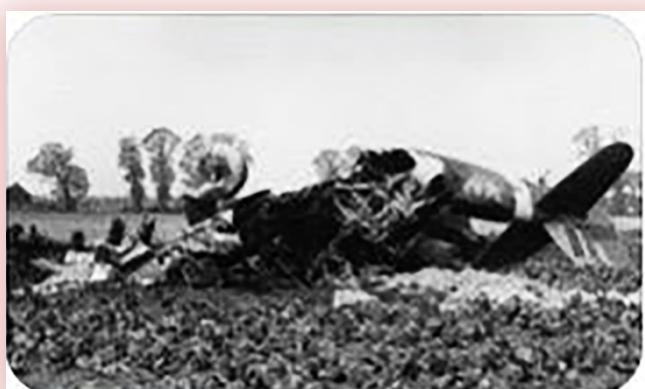
Several residents saw a fighter plane (**) in difficulties on Sunday evening and they were confident from the manner in which it was flying that it would come down onto a row of houses. The pilot, however, managed to steer the machine between a farmhouse and a tree and after narrowly missing a row of houses, he landed in a field, only a few yards from another lot of houses.

**Crash site:
Hawker Typhoon
Preservation Group**

(**) Typhoon 1B flown by F/O Lowey who forced landed and was slightly hurt.
