Troublesome Typhoons

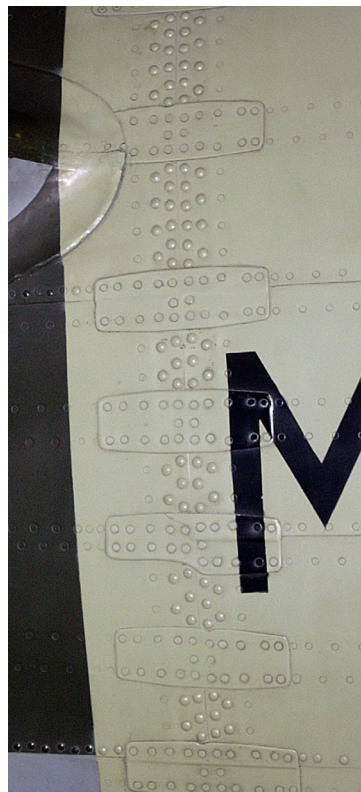
A repair carried out in accordance with Mod No. 239 on Hawker Typhoon 1B (MN235) believed to be the only surviving Typhoon, now on display at the RAF Museum in Hendon.
